Hazelbeck Accessibility Action Plan April 2023

4.1 - ACTION TABLE

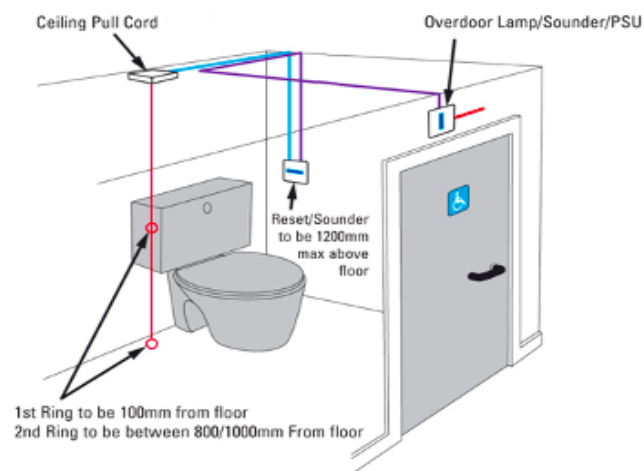
13.11

Cord alarms across the facilities were unsuitably positioned.

The cord alarms in HK 55C, HK57C, HK60.3, and HK60.2 were tied and not hanging within a suitable distance to the floor.

A broken cord alarm was identified in HK57B.

No cord alarm systems were identified in HK58B or HK58E.

Cord alarms in HK60.4 and HK57E were positioned behind items and could be difficult to access.

Should someone using these facilities required the cord alarms, but cannot reach them, their distress calls may go unnoticed.

According to BS8300 - An emergency assistance pull cord should be sited so that it can be operated from the WC and from an adjacent floor area. The emergency assistance pull cord, coloured red, should be provided with two red bangles of 50 mm diameter, one set at a height between 800 mm and 1000 mm and the other set at 100 mm above floor level.

Implement a management procedure to ensure that cord alarms are always kept loose and not tied up.

Utied - Amey to monitor on routine check
MJA to check
Hygiene rooms not requiring alarm
Students generally have supervision and no incidents in the last 12 years regarding these toilets. Teaching staff and support have access to all the student EHCP and would put in appropriate support

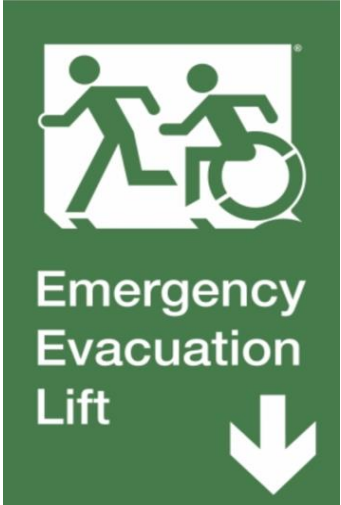
17.4	<p>The auditor was informed that the lifts could be used in the event of a fire evacuation. The lifts featured signage that indicated that they could not. This could lead to confusion during an emergency evacuation.</p>

<p>Lifts are the most appropriate means of evacuation for some people, and the use of either an evacuation lift or a conventional passenger lift providing the functionality of an evacuation lift should be incorporated into an evacuation strategy.</p> <p>BS9999: A lift to be used for the evacuation of disabled people should usually be either an evacuation lift or a firefighters lift, and should be operated under the control of the fire safety manager or a delegated representative, or otherwise by someone trained and authorized in the use of the lift. Evacuation lifts should be provided, constructed and operated in accordance with Annex G.</p> <p>A lift that is not explicitly designed for evacuation may be used for evacuation, provided that it provides the same functionality as an evacuation lift. If this is to be considered as an option then a suitable risk assessment should be undertaken to evaluate whether the lift meets the recommendations given in Annex G: <i>lifts used as part of the evacuation sequence for persons with disability and persons requiring assistance, which has appropriate structural, electrical and fire protection and is capable of being taken under control by a trained and authorized person</i></p> <p>Should the lifts be suitable to use in the event of an evacuation, they should be clearly identified by appropriate Fire Safety sign and included as appropriate for disabled people in any PEEPs.</p>	M	<p>Signage has been placed on the lifts advising Haz trained staff able to use in a fire.</p>

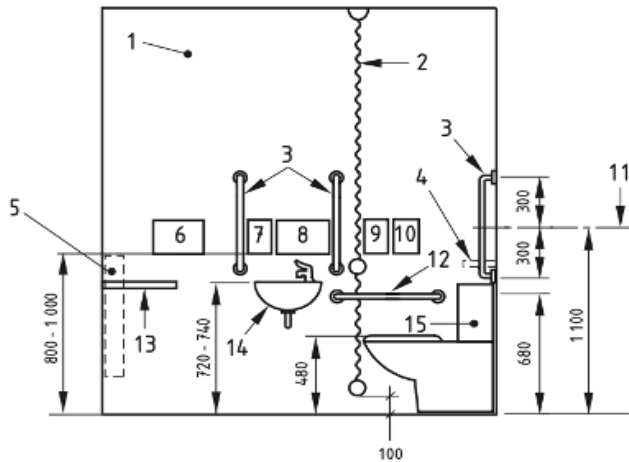
13.5	<p>The soap dispenser was not provided at a height of approximately 1050mm in HK60.1.</p> <p>The hand towel dispenser was high in HK57B, at approximately 1215mm.</p> <p>There are fittings across the WC facilities that do not provide contrast against their surroundings as they are white against a light background.</p>	<p>The dispensers should be relocated at a height of between 800mm and 1000mm above finished floor level., as indicated by BS8300 Figure 42.</p> <p>Greater contrast should be considered for the fixtures and fittings within the WCs. This can be achieved by having light sanitary ware seen against a dark background or vice versa.</p> <p>According to BS8300 - to help blind and partially sighted people identify key objects within sanitary accommodation, support rails and grab rails should contrast visually with the wall, the WC seat and cover should contrast visually with the WC pan and cistern, and sanitary fittings and accessories should contrast visually with the background against which they are seen.</p>	M	<p>These are in the correct location. Students generally have supervision and no incidents in the last 12 years regarding these toilets. Teaching staff and support have access to all the student EHCP and would put in appropriate support.</p>																
13.5	<div>

<div><p>Height of drop-down support rails to be the same as the other horizontal grab rails.</p><p>Key</p>

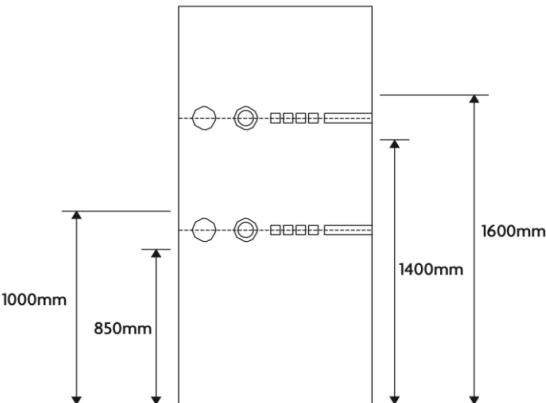
5.9	<p>The glazed doors did not feature manifestations at two heights, to assist with reducing the risk of a collision.</p>	<p>All full height glazed areas must be clearly highlighted with manifestation that contrasts visually with the surface behind it under both natural and artificial lighting conditions, from all likely viewing directions. This manifestation should be located within two zones, from 850mm to 1000mm from the floor and from 1400mm to 1600mm from the floor.</p>

<p>Manifestation can take various forms, e.g. broken or solid lines, patterns or company logos</p>	M	<p>Change notice ask for two heights of stickers on the door.</p>

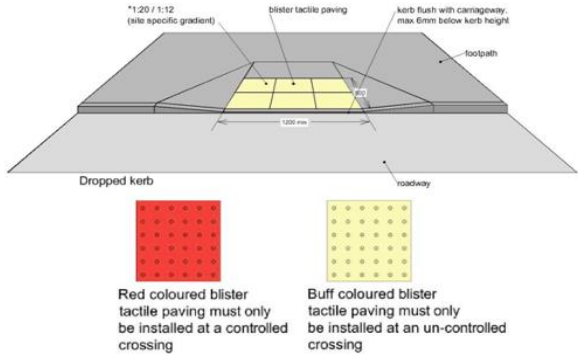
1.2	<p>Crossing points on approach to the school featured dropped kerbs and tactile paving.</p> <p>The crossing point next to the car gates and intercom systems featured slightly damaged tactile paving, which could cause confusion for people who are partially sighted.</p> <p>The crossing next to the main, school gates was faded and requires remarking.</p>	<p>Site management to schedule repair of the tactile paving to replace the broken areas.</p> <p>The crossing point requires remarking to ensure that it is clearly distinguishable.</p>

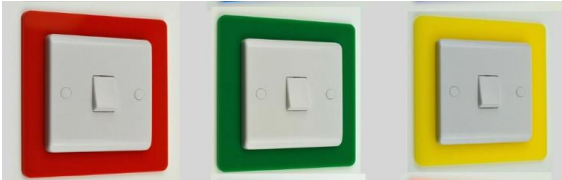
16.2	<p>Dimmer switches were identified to assist with gradually controlling light levels.</p> <p>Many of the light switch plates provided were white against a light background, which provides minimal contrast to assist people who are partially sighted.</p>	<p>At the next refurbishment for the sites, it would be beneficial to change the existing light switch plates with alternatives that have a grey/silver plate. This will ensure that they are easily located by people with impaired vision.</p> <p>All switches that require precise hand movement, such as light switches, thermostats etc, should be located between 750mm – 1200mm from floor level.</p>
